Manhole Inspection Summary

Manhole # S15G__001MH

Insp Date: **2/26/08 8:52 AM**

Location Address: **2712 alley-fairmount-kinsey** Cross Street: **franklintown rd**

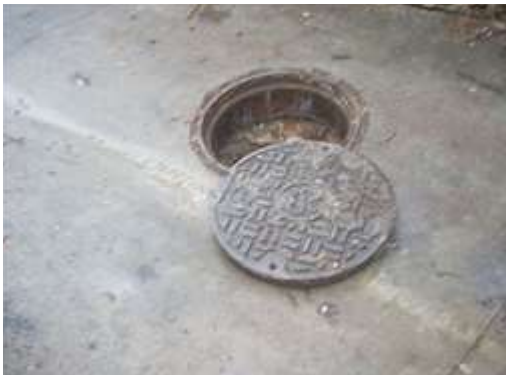
Misc

Manhole Type: **Inline** Location: **Alley** Ground Conditions: **Wet**
☐ Prev. Rehab Weather: **Light Rain** Subject To Ponding: **Sheeting**

possible subject to sheeting

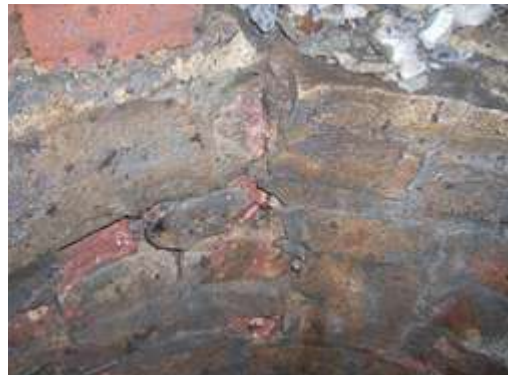
Defect 4

Condition: ☐ Sound ☒ **Cracked** ☐ Root Intrusion ☐ Loose Brick ☒ **Deteriorated**

cracked corbel

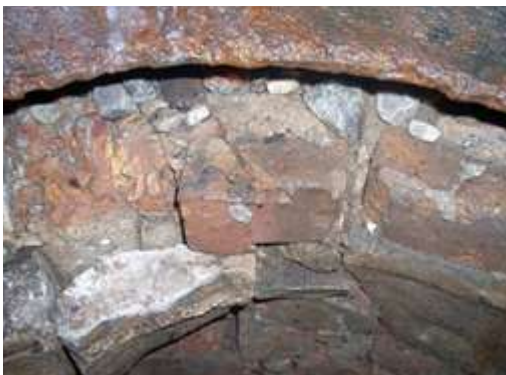
Defect 3

Condition: ☐ Sound ☒ **Cracked** ☐ Root Intrusion ☐ Loose Brick ☐ Deteriorated

cracked chimney

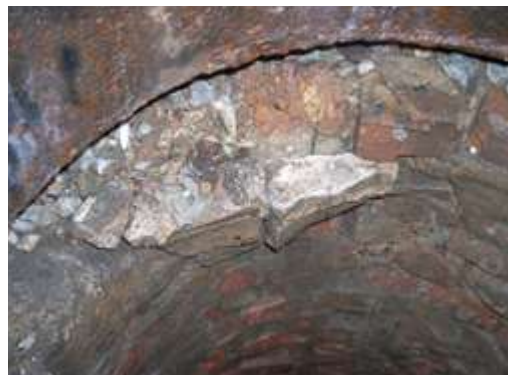
Defect 2

deteriorated corbel

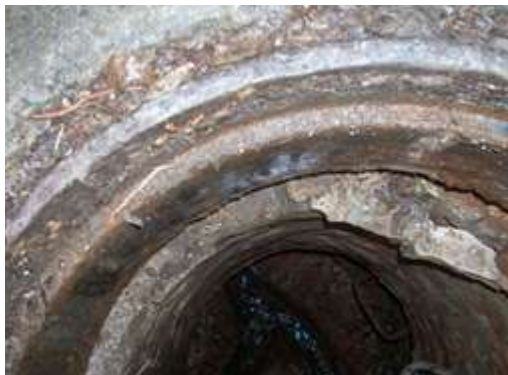
Defect 1

Frame Offset: **1** (in.) Condition: ☒ Sound ☐ Cracked ☐ Leaks

frame offset

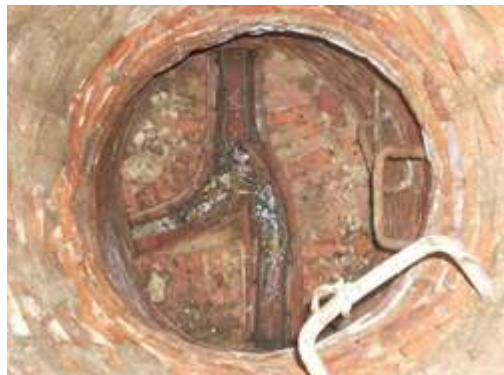
Defect

Steps Count: **3** Missing: **0** ☒ **Corroded**

Corroded Steps
